**ENVIRONMENTAL STATUS REPORT FOR THE PARKHAVEN PAN AND
CONSERVATION AREA AT PARKHAVEN EXTENSION 5**

NOVEMBER 2012

ANNUAL ENVIRONMENTAL STATUS REPORT

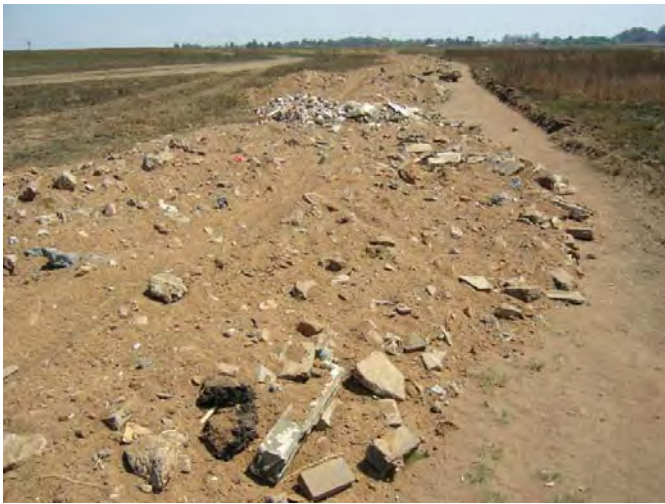
Historic Dumping on the site (2007)

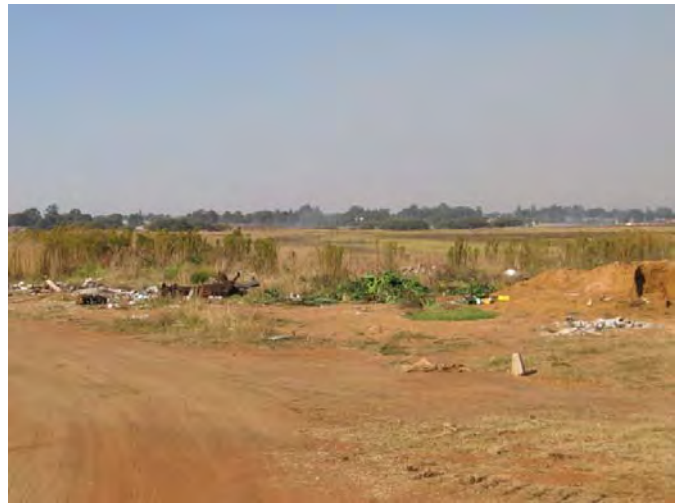
Litter and Rubble at northern side of the pan area (2007)

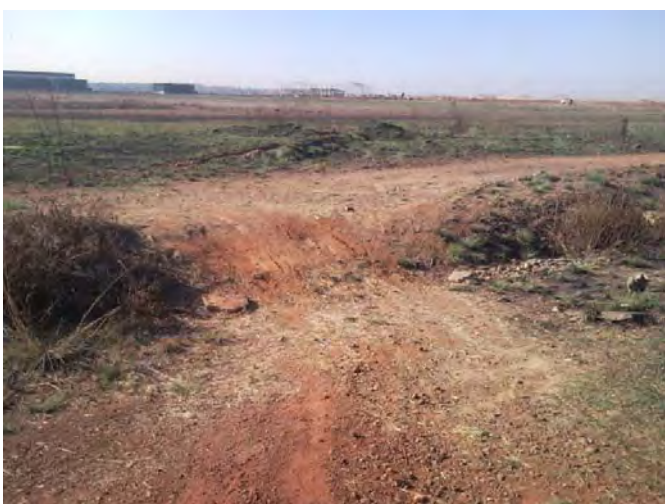
Old dirt road through the site prior to new perimeter fence (2010)

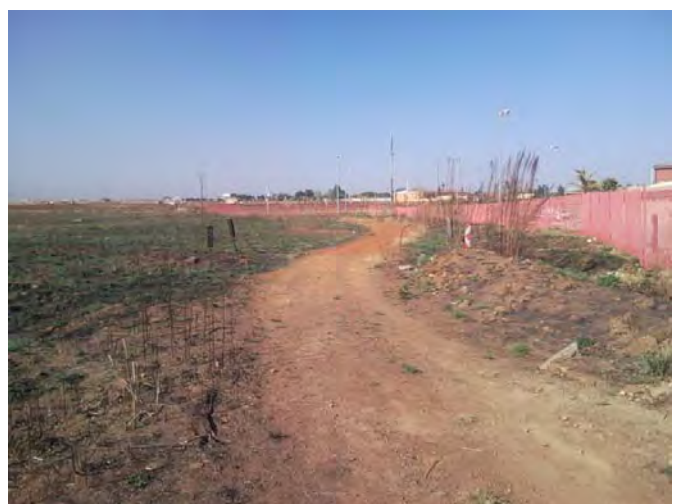
Site access is now restricted by a palisade fence (2010)

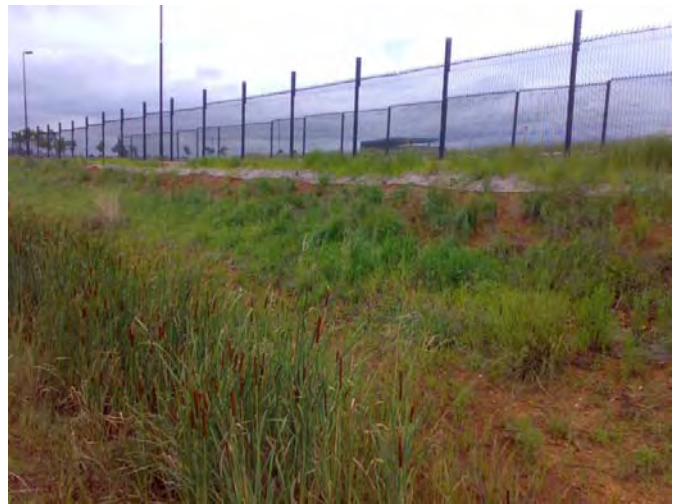
The rehabilitated bio-swale. Subsequent photo's below will show the change from 2010 to current (**2012**)

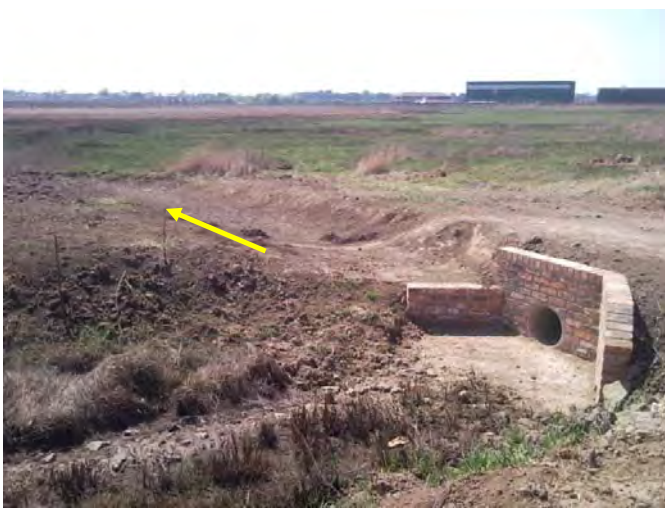
Overflow design with low spillway to direct the high rainfall events into the pan to minimize downstream impacts

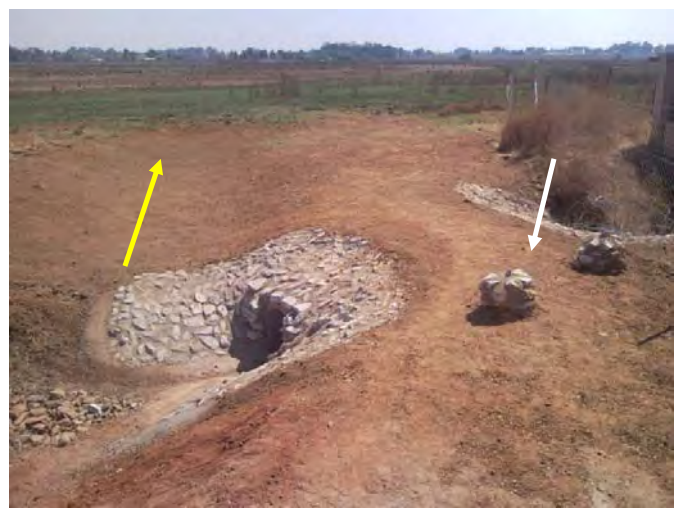
Revised design, with lower spillway for the 10yr or greater flood as well as barriers to restrict access to pan area (arrow)

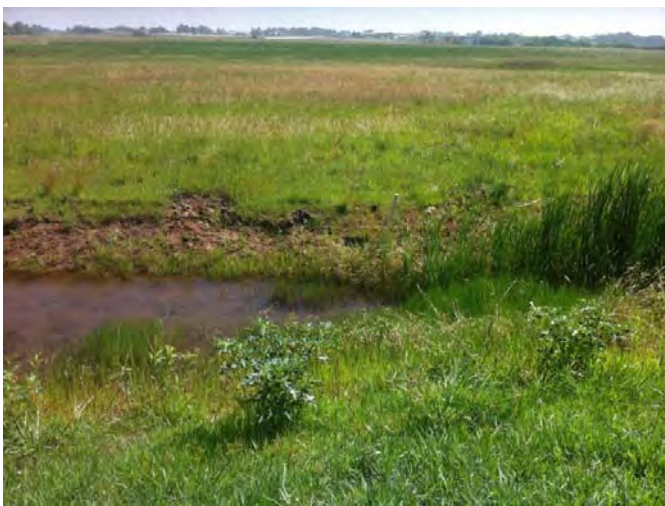
Bio-swale has improved significantly and the eradication program continues to remove exotics (2012)

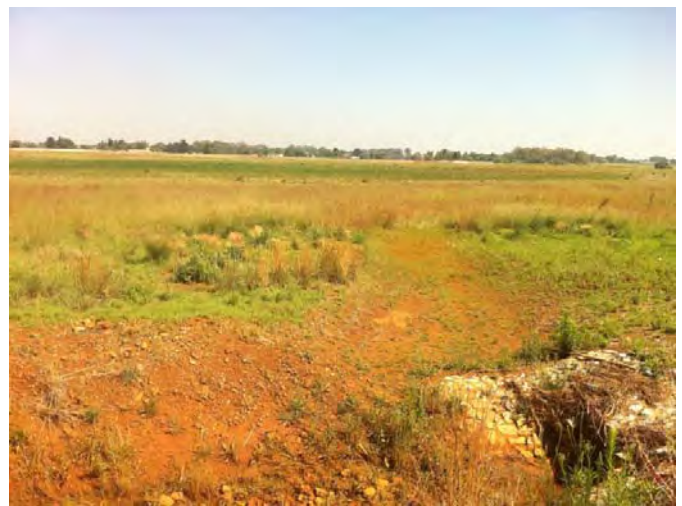
Spillway of the attenuation structure, as detailed above, shows the rehabilitation and progress of the spillways (2012)

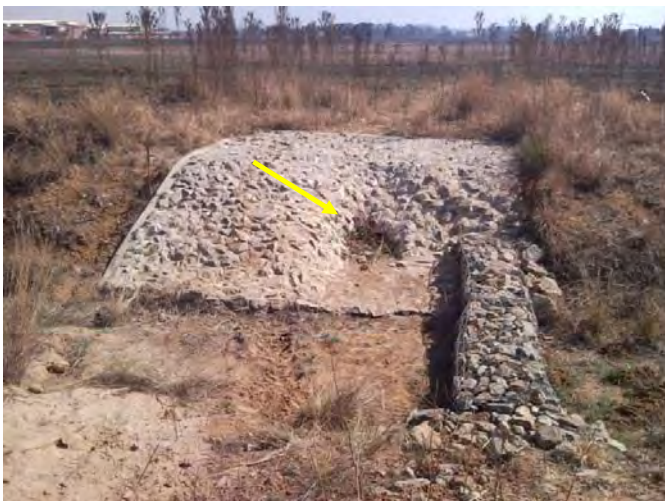
Low attenuation structures and gabions within the bio-swale. A subsoil drain was installed to feed the wetland (2010)

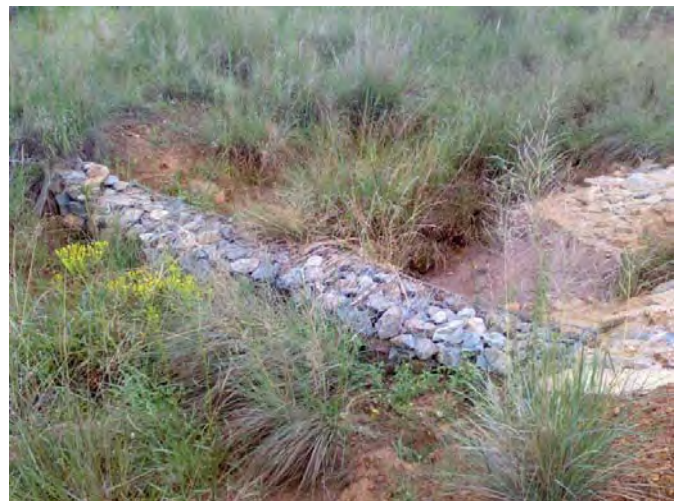
Regrowth of vegetation around the gabions within the bio-swale. The vegetation has re-established well (2012)

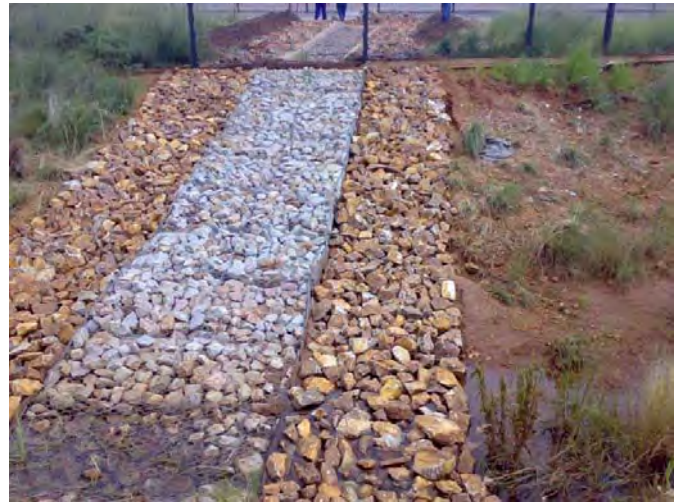
Additional rocks were placed on either side of the rock mattress to further minimize erosion in the bio-swale **(2012)**

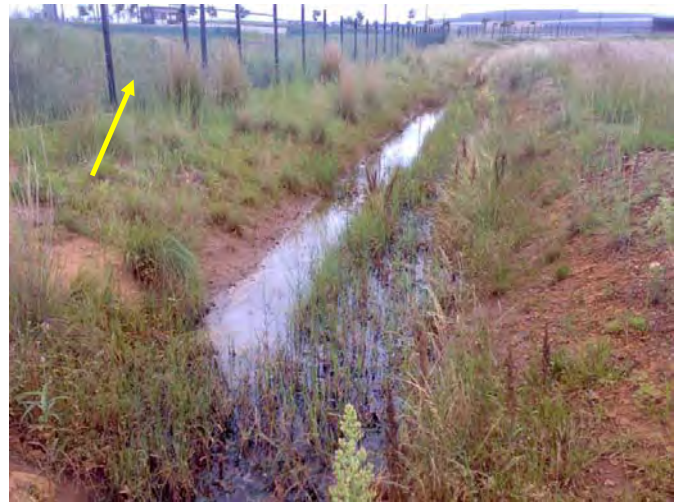
Bio-swale showing good establishment of the wetland grasses and sedges and the new clear-vu fence **(2012)**

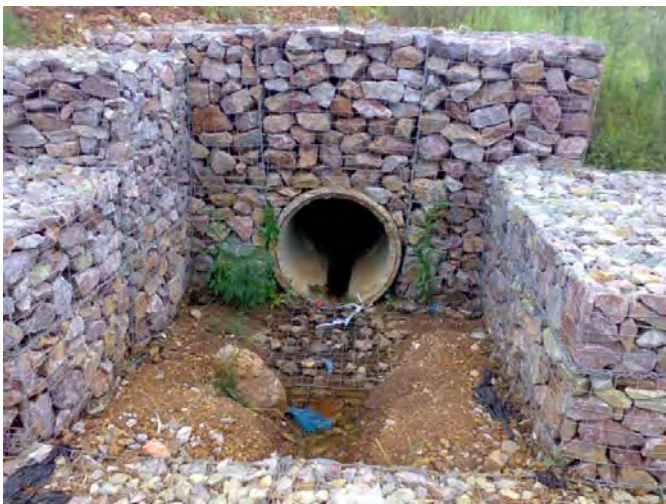
Design of the storm water outlets act as silt traps and litter traps. Vegetation will establish in outlets and gabions **(2011)**

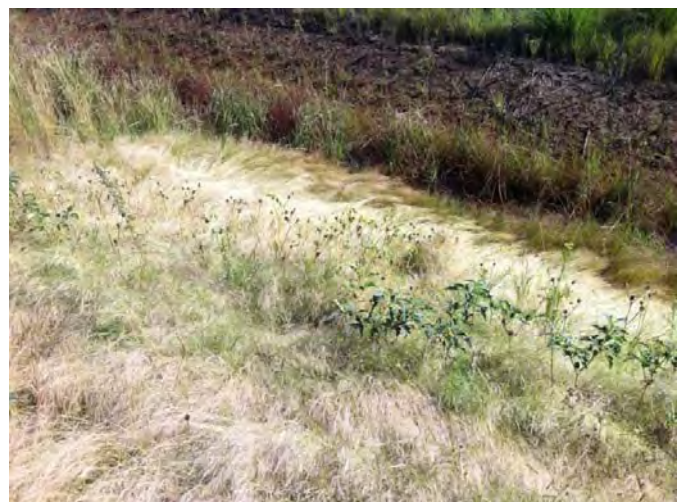
Hydro-seeding taking but exotic plants an issue (**2010**)

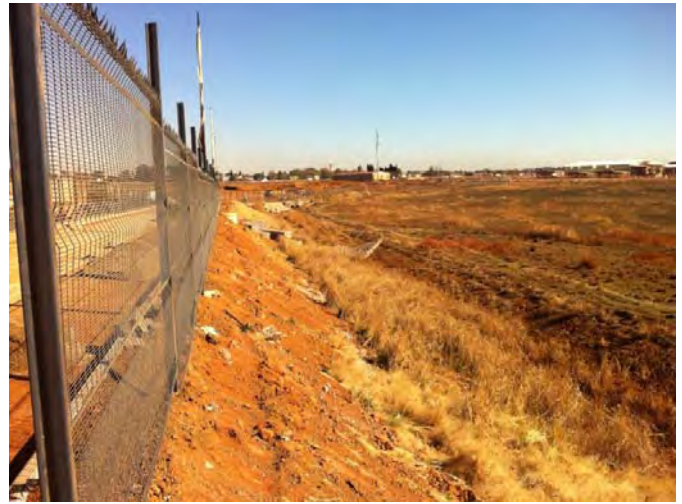
Embankment prior to erosion control measures and hydro-seeding required after new Clear-vu fence installed (2011).

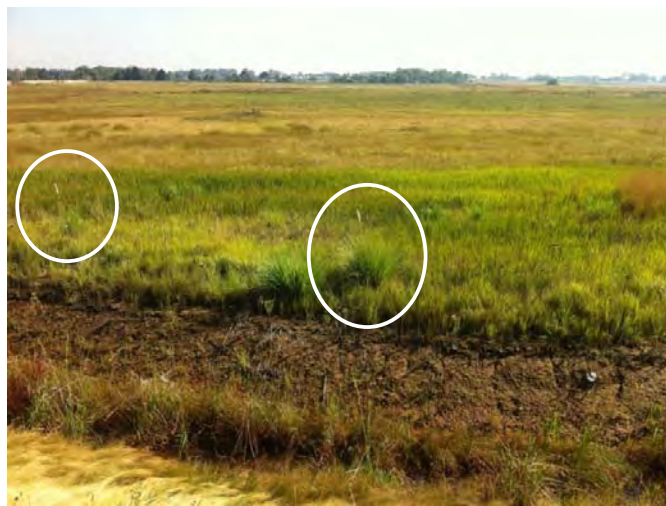
Pampas grass on the southern edge of the storm water swale. Not as urgent to remove but will spread into pan area (2011)

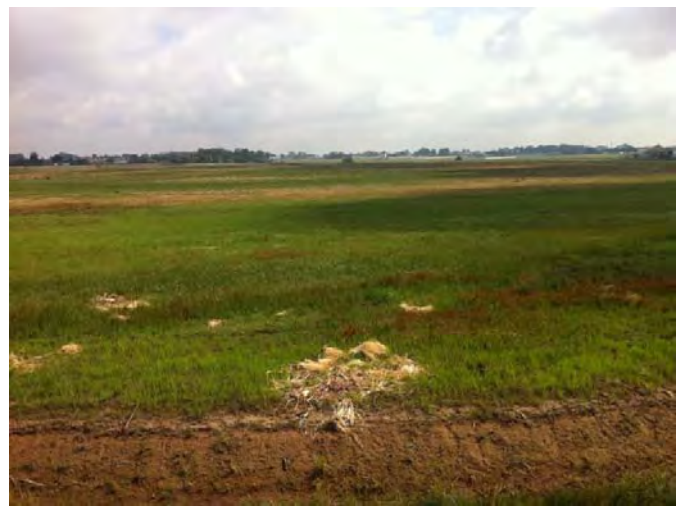
Eradication of the Pampas grass (*Cortaderia selloana*), a Category 1 weed, as part of the eradication program (2012)

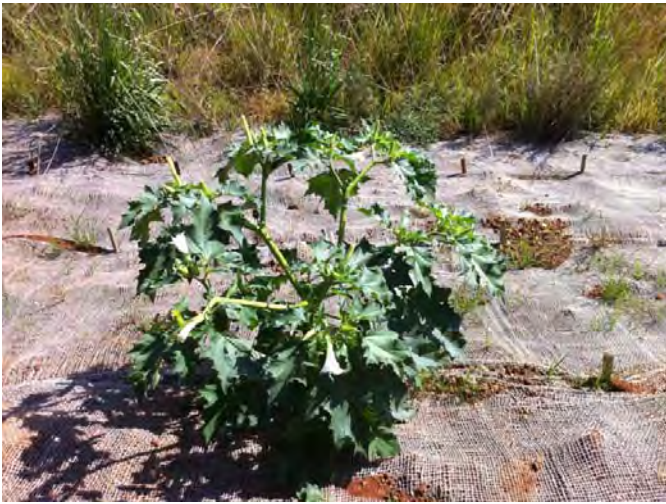
Exotic Spiny Thorn-Apple (*Datura stramonium*) – Cat 1 weed that has invaded the exposed embankments of the bio-swale. These have been manually removed or slashed

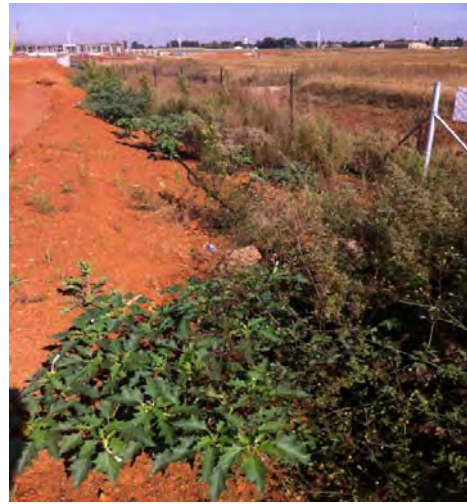
Exotic plants along the Toyota site as well as within the bio-swale buffer area (2010)

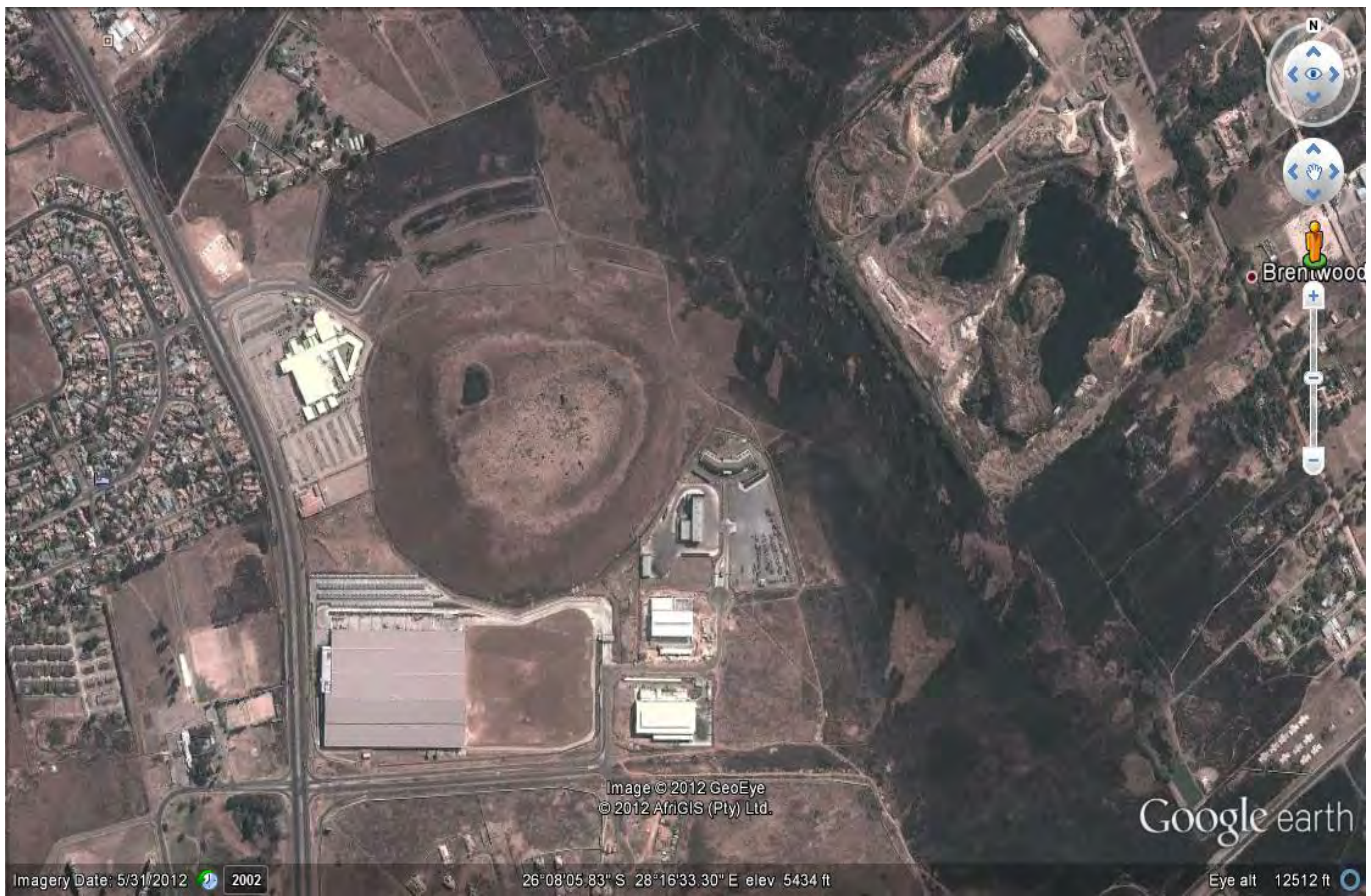
Figure 2: Most recent aerial photo of Parkhaven Ext 5 and Pan taken from Google Earth, dated **31st March 2012**. A fire has burnt most of the eastern properties however the pan itself is unburnt due to a high water table. The pan however did experience a large burn which resulted in a favourable condition, in that a greater internal percentage of the pan experienced a burn which has not occurred in at least 5 years. Fire is a requirement of any natural veld / wetland system however **fires must not occur every year, a more favourable fire cycle is every 3 – 5 years.**

The implementation of adequate fire breaks around the pan is a recommendation as a management tool to try control annual wildfires. This would require the slashing of the rank grassland vegetation around the entire perimeter of the conservation area as depicted by the blue line in aerial photograph above (**Figure 1**).
